Construction Site Mapping

Aderbal Correa and Janggam Adhityawarma
Center for Environmental Technology
Department of Civil & Environmental Engineering
University of Missouri-Columbia

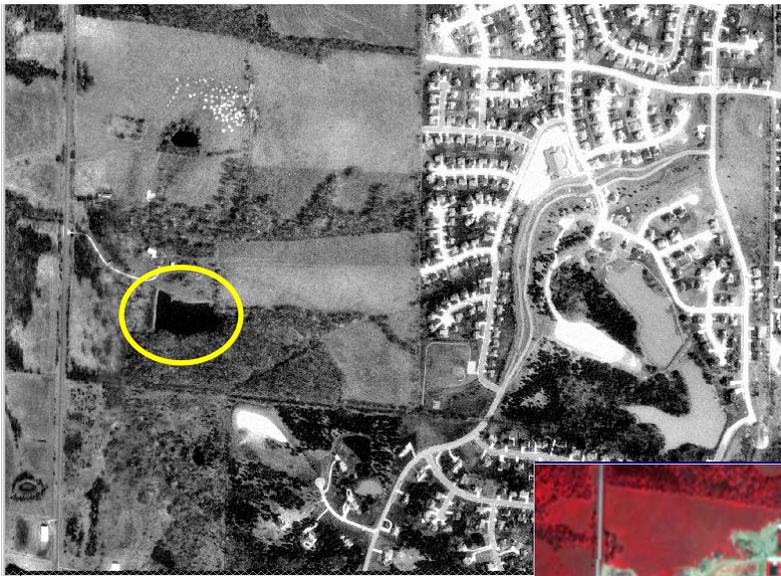
a) Aerial photo mosaic 1996

Figure 1. Images a, b and c show the evolution of urban growth in southwest Columbia (Heritage Estates development). The April 2000 Ikonos image (b) shows high turbidity in a pond caused by sediment transported from the construction area. The problem is much smaller four months later (c) when roads are paved. The pond is not visible from nearby roads.
